Spot Safety Project Evaluation

Spot Safety Project # 03-97-401

**Spot Safety Project Evaluation, of the Flashing Traffic Signal Actuation and
The Installation of Post Mounted “Vehicle Entering When Flashing” Signs,
At the Intersection of NC 11 and SR 1102-Charity Road, in Duplin County**

Evaluation of Spot Safety Project Number 03-97-401 – The Intersection of NC 11 and SR 1102-Charity Road in Duplin County

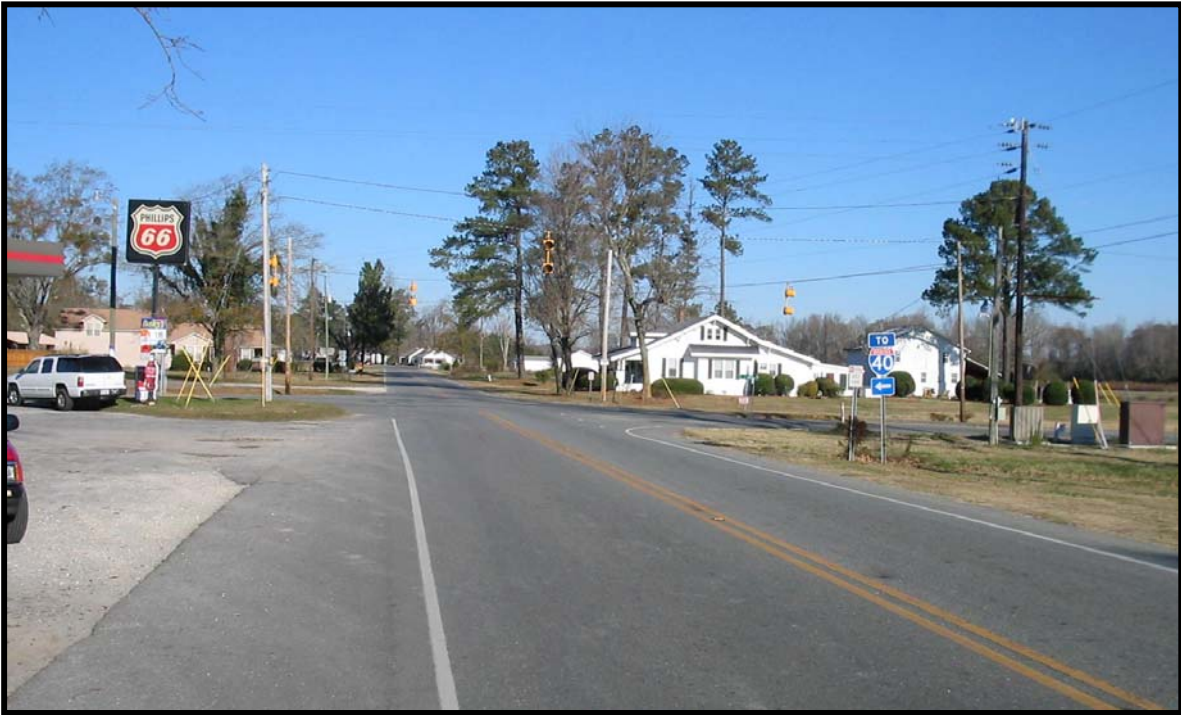
Treatment Site Photo (Taken on December 15, 2004)

Looking north on NC 11

Please see the attached *Treatment Site Location Photos*. Photos are provided for each leg of the treatment intersection. Also note the photo which shows the limited sight distance from the westbound SR 1102-Charity Road approach due poles and large trees in the yard of the private residence located in the northeast quadrant.

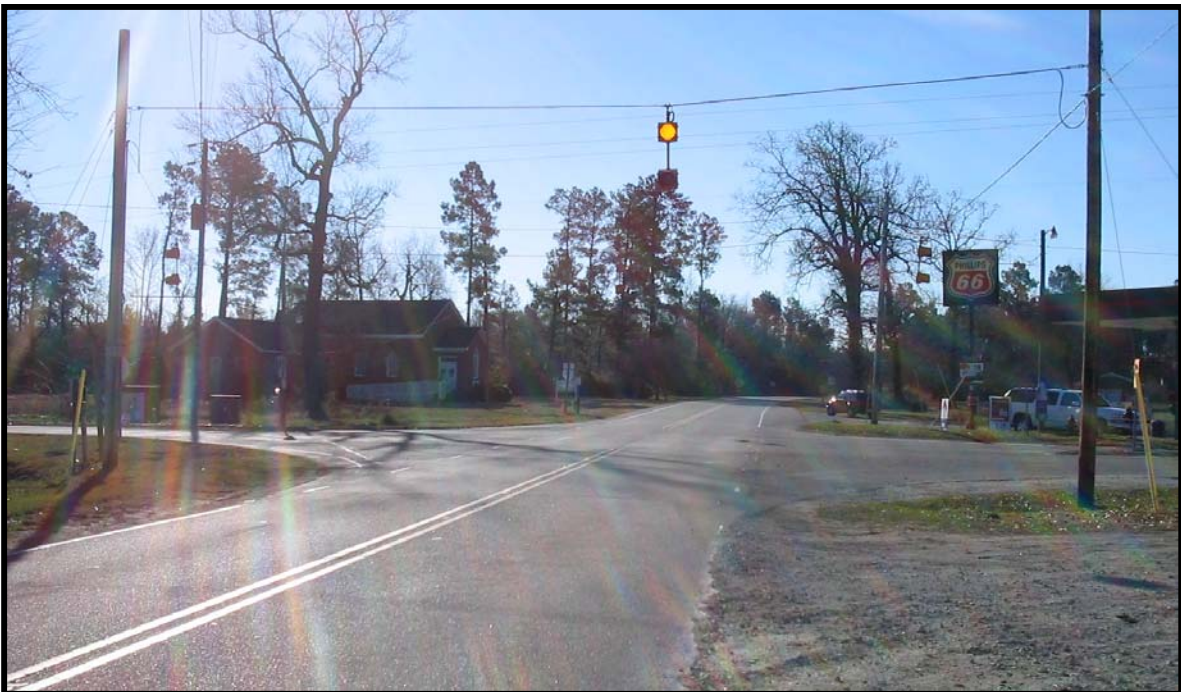
Looking south on NC 11

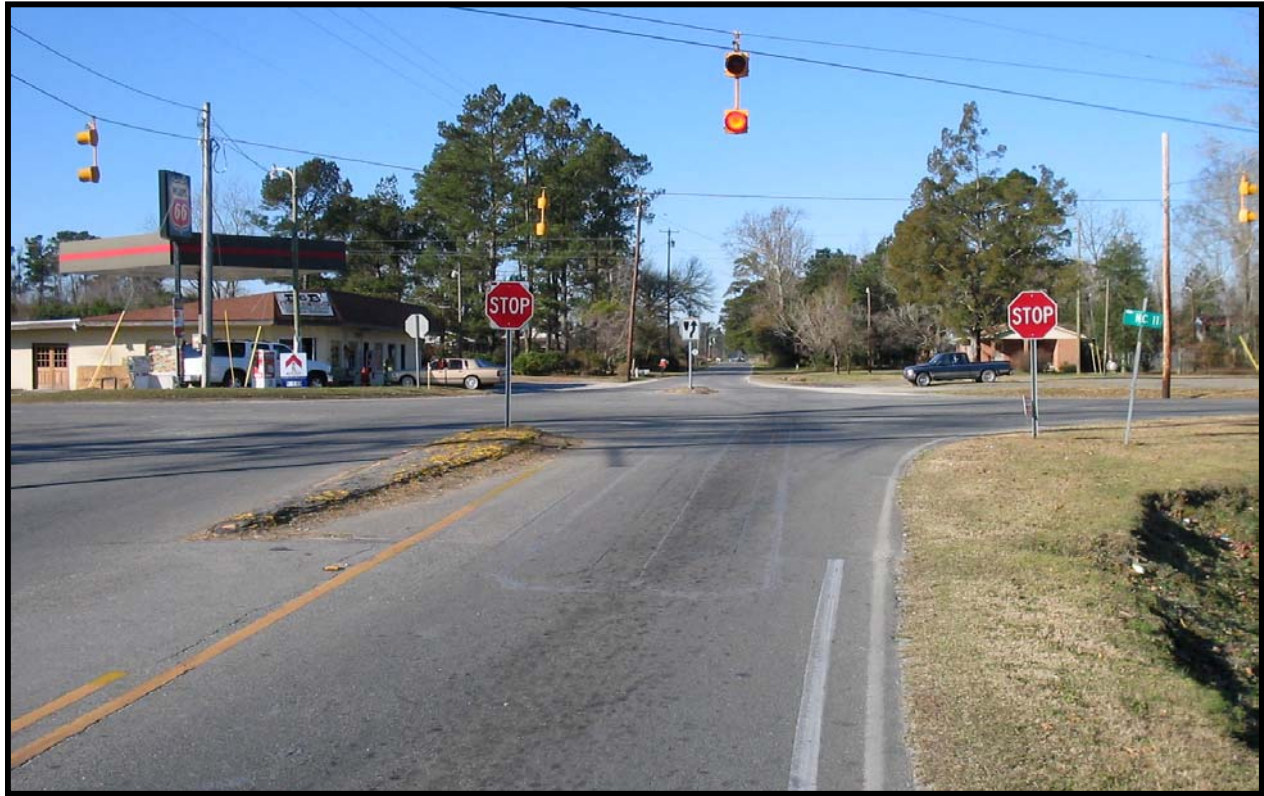
Treatment Site Photo (Taken on December 15, 2004)

Looking west on SR 1102-Charity Road

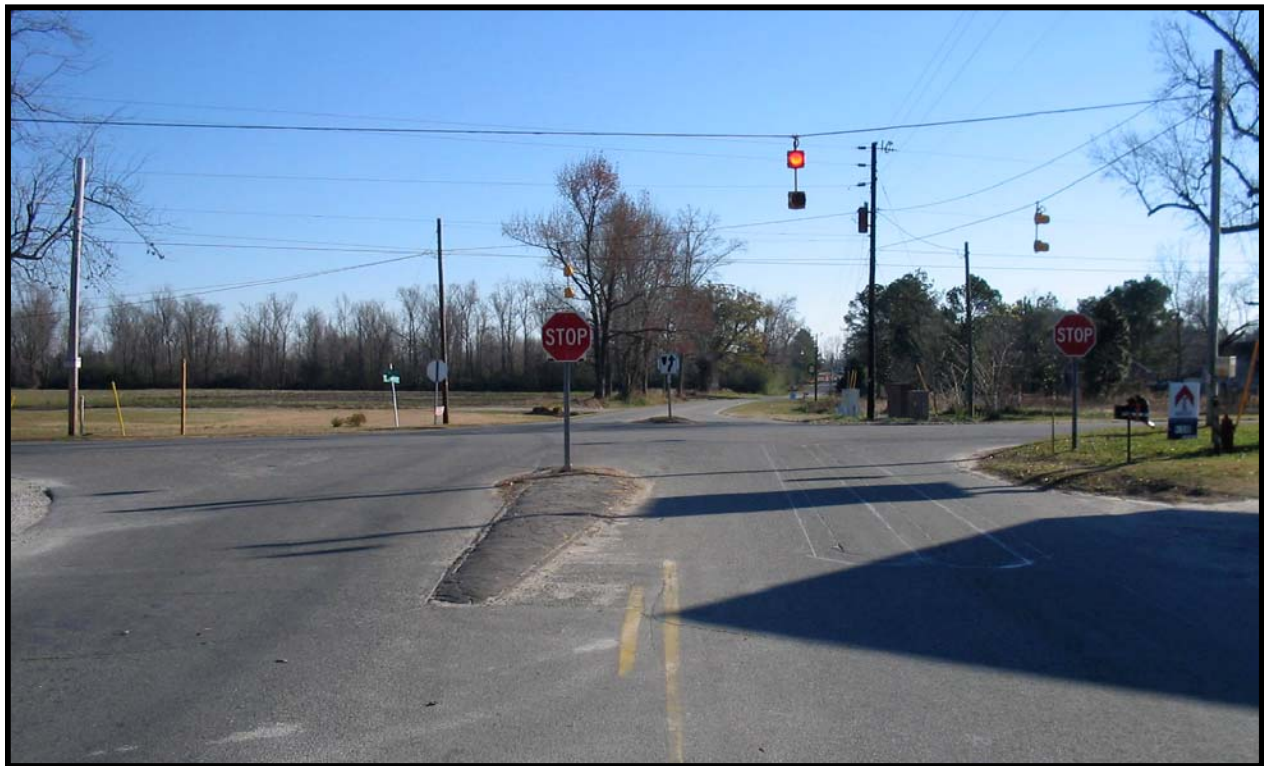
Looking east on SR 1102-Charity Road

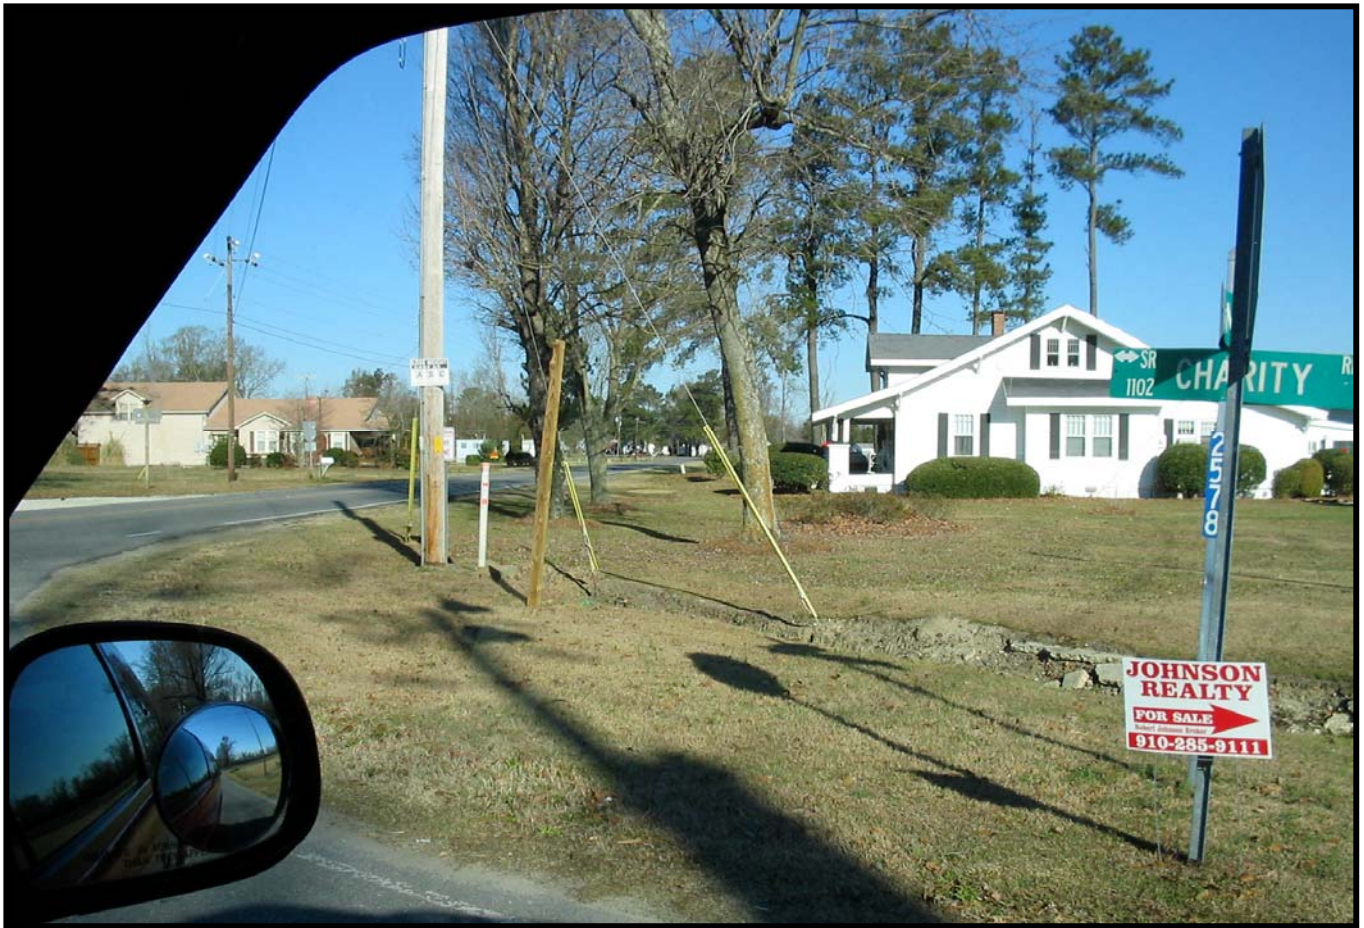
Treatment Site Photo (Taken on December 15, 2004)

Looking north on NC 11, from westbound SR 1102-Charity Road
Notice poles and trees blocking the view of oncoming traffic.

A pattern of motorists on SR 1102-Charity Road entering the path of vehicles on NC 11 developed, causing Angle type crashes. Sight distance is limited from the SR 1102-Charity Road approach due to the gas station/ convenience in the southwest quadrant and poles and large trees in the yard of the private residence located in the northeast quadrant. The initial crash analysis for this location was completed from January 1, 1993 through December 31, 1995 with a total of 20 reported crashes. There was 17 Angle Crash, one Left-Turn Crash, one Backing Crash, and one Other Collision With Vehicle Crash. Two class A, four class B, and 18 class C injuries resulted. The final completion date for the improvement at the subject intersection was on January 29, 1998.

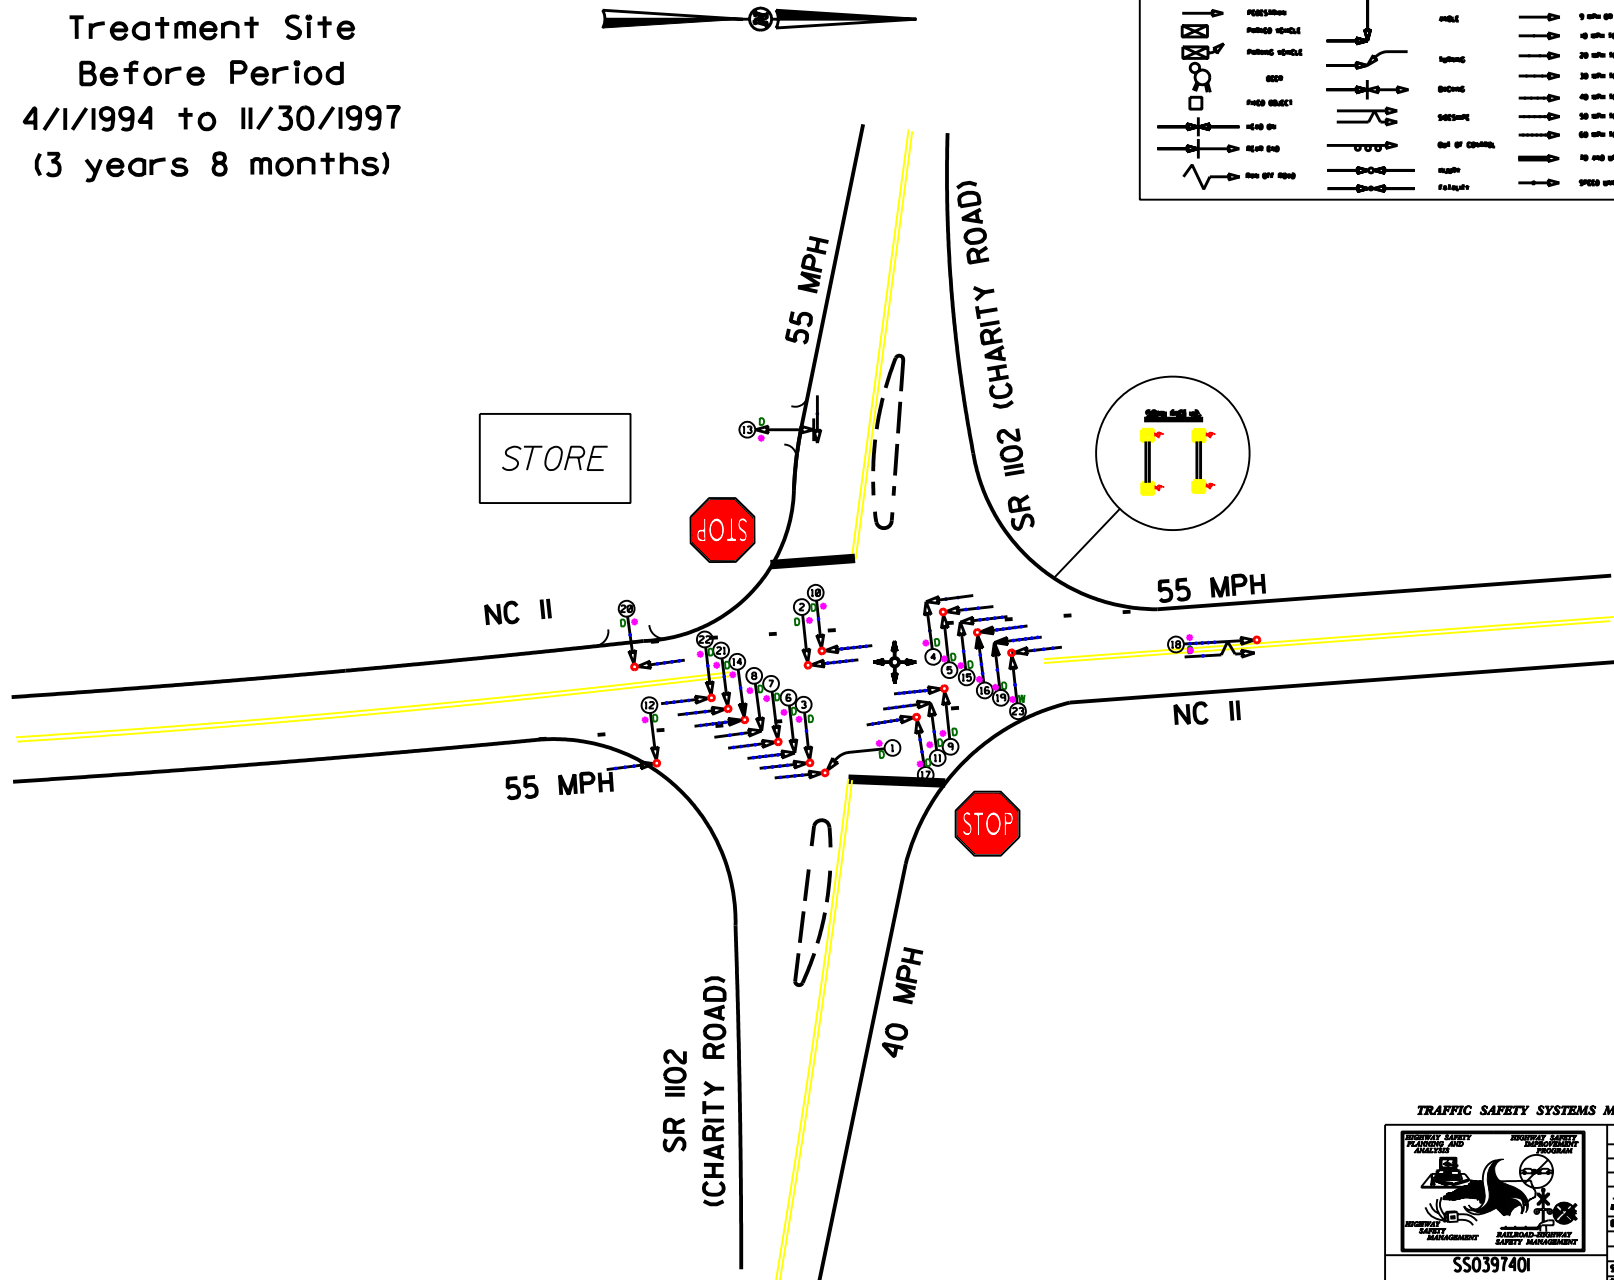
Treatment Site
Before Period
4/1/1994 to 11/30/1997
(3 years 8 months)

COLLISION DIAGRAM	
	Project:	Area:
	Study Period:	Page: 1 of 1
	Diagram Prepared By: C. J. [Name]	Diagram Reviewed By: [Name]
SS0397401		Scale: Not to Scale
Before		Date: [Date]
N.C. DEPARTMENT of TRANSPORTATION DIVISION of HIGHWAYS TRAFFIC ENGINEERING AND SAFETY SYSTEMS BRANCH

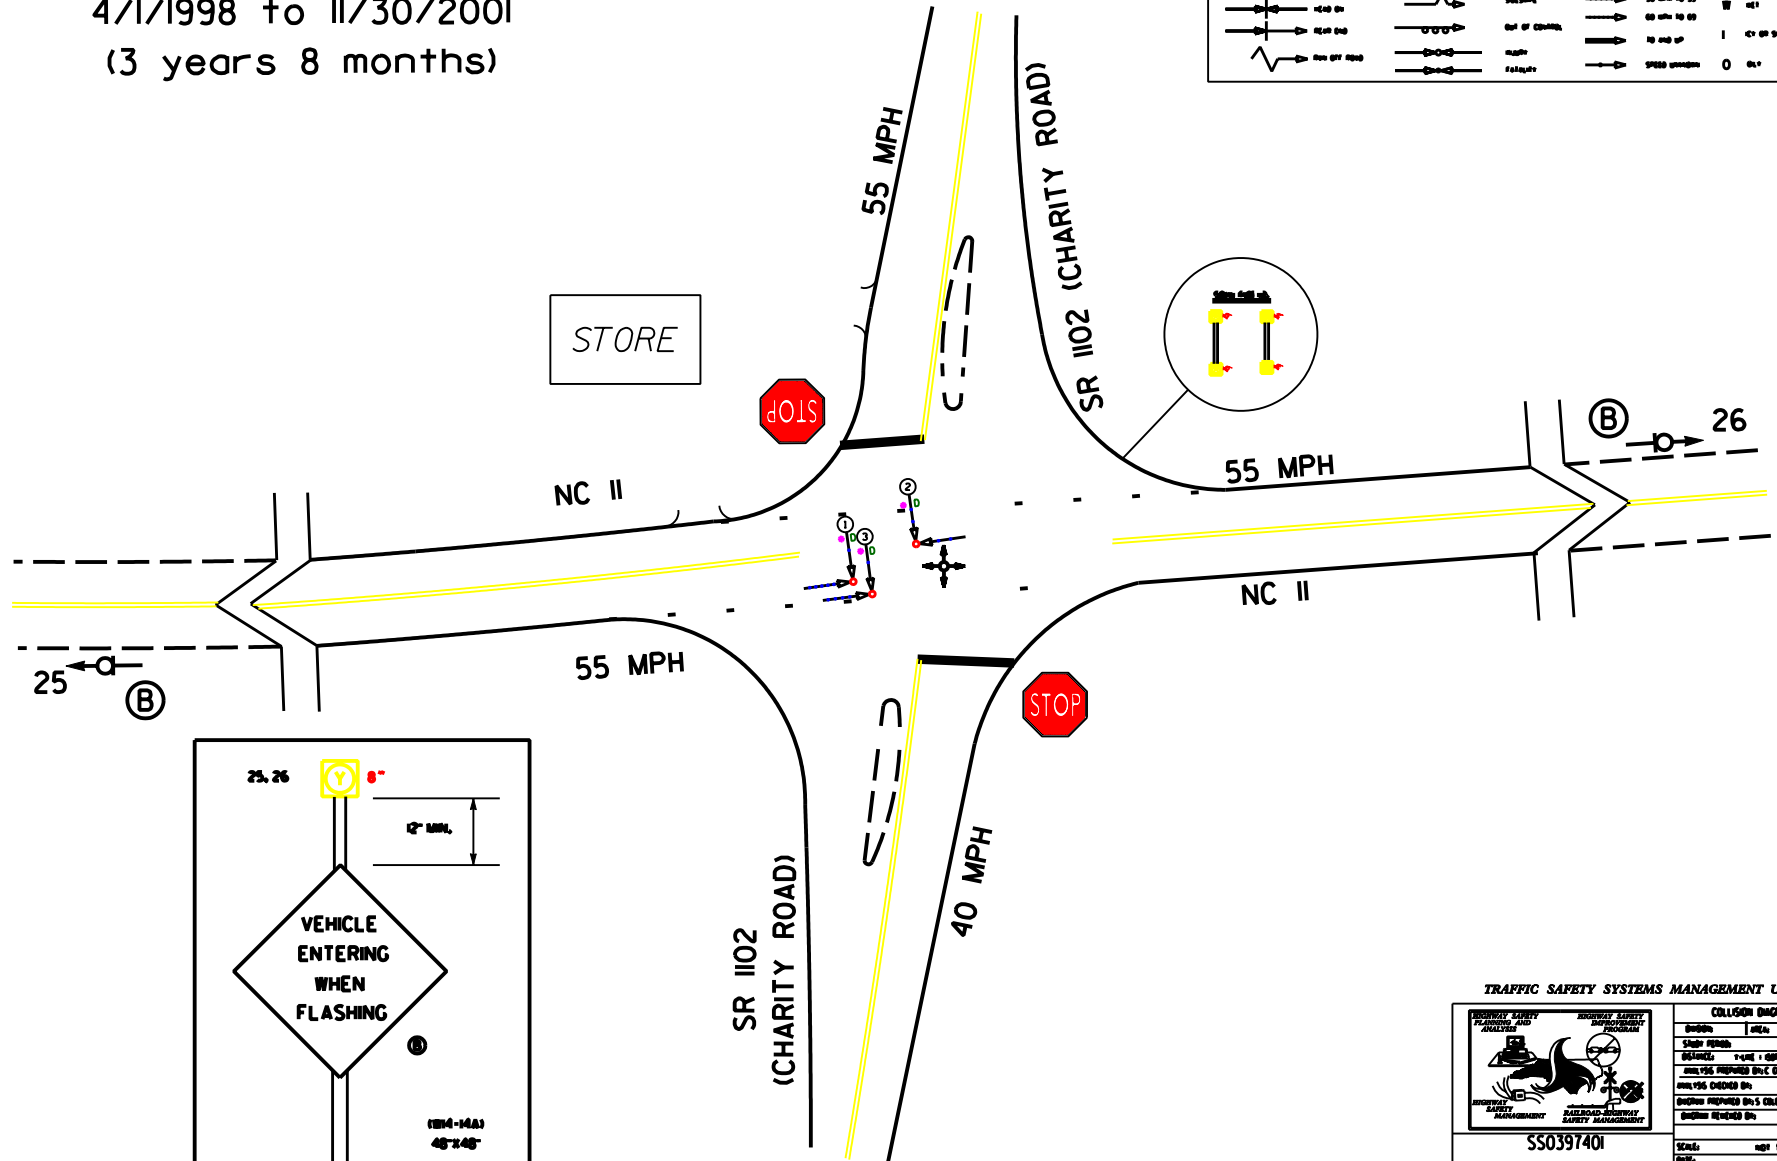
Treatment Site
After Period
4/1/1998 to 11/30/2001
(3 years 8 months)

<table><tr> <th colspan="2">COLLISION DIAGRAM</th> </tr></table>
